ANNUAL REPORT

ARCHÆOLOGICAL SURVEY OF INDIA

1923-24

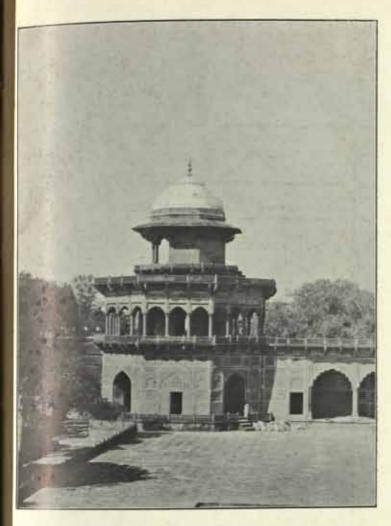
annual repairs. At Agra, the chief work was the rebuilding of the south-west United corner chhatri at the Taj. On account of cracks in its dome and the breaking Provinces of most of the lintels, brackets, capitals and bases of pillars as a result of the Muhammadan sinking of its plinth, the whole of the chhatri was in a precarious condition. Monuments As a temporary measure, three of its openings had been filled in with brick Agra masonry walls to support the most affected parts (Pl. I,a), until funds could be made available to rebuild it. In the reconstruction every care has been taken to re-use as far as possible the old serviceable stones, and with this object all the stones were numbered and photographed before dismantling (Pl. I,b). The work of dismantling and lowering the heavy stones from a height of some 80 feet was not without difficulty and danger, requiring a heavy scaffolding (Pl. I,c), strong ropes and pully blocks and the task was made all the more complex owing to the extreme care that had to be taken to avoid damage in the removal of the stones. In the course of dismantling it was found that the cupola of the chhatri was not constructed on the usual dome principles. Instead, it was built as a solid mass with exterior and interior facings of marble and red sandstone respectively, the interspace between these facings being filled in with a brick masonry core. The facing stones were held in position with iron clamps and dowels, while bonding slabs fixed with iron clamps held together their respective inner and outer courses (see fig. 1).

(a) SOUTH-WEST CHATTRI AT THE TAJ, AGRA, BEFORE CONSERVATION.

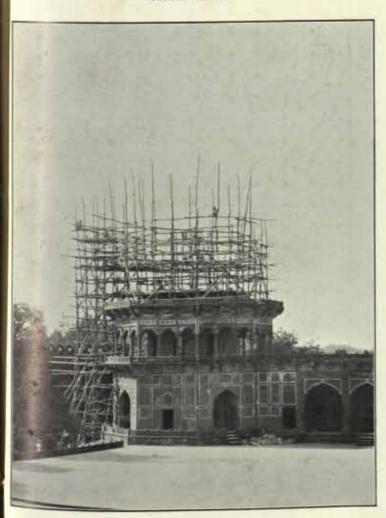
(c) SOUTH-WEST CHATTRI AT THE TAJ, AGRA, AFTER DISMANTLING.

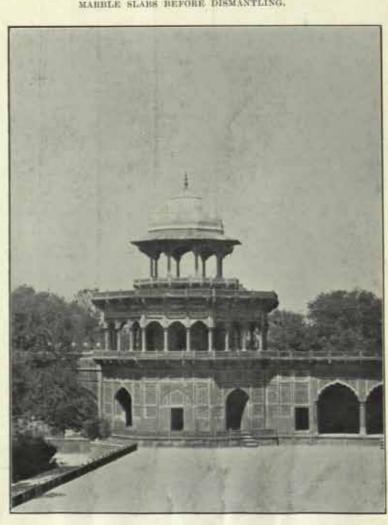
(b) SOUTH-WEST CHATTRI AT THE TAJ, AGRA, SHOWING NUMBERING OF MARBLE SLABS BEFORE DISMANTLING.

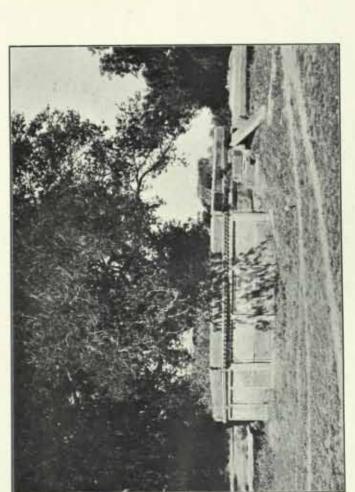
(a) Well near the Dak Bungalow, Sikandra, Agra, before conservation.

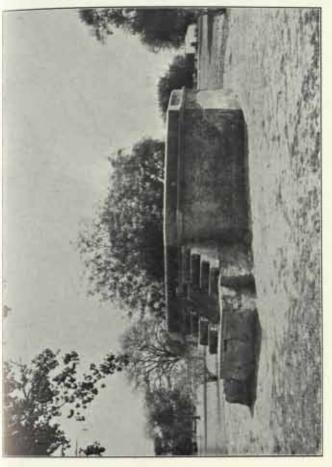
(c) Well near the cook house of the Dar Bungalow, before conservation.

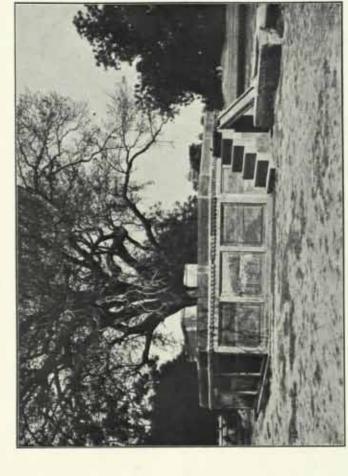
(b) While near the Dak Bungalow, Sikandra, Agra, after conservation,

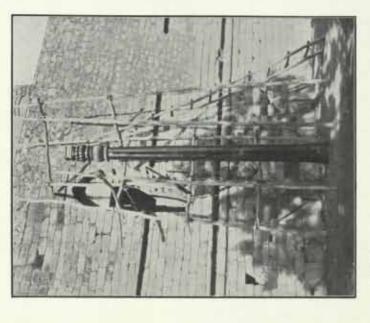
(b) Khas Mahal at Fatishdir Sikri, showing chhajja after bepairs,

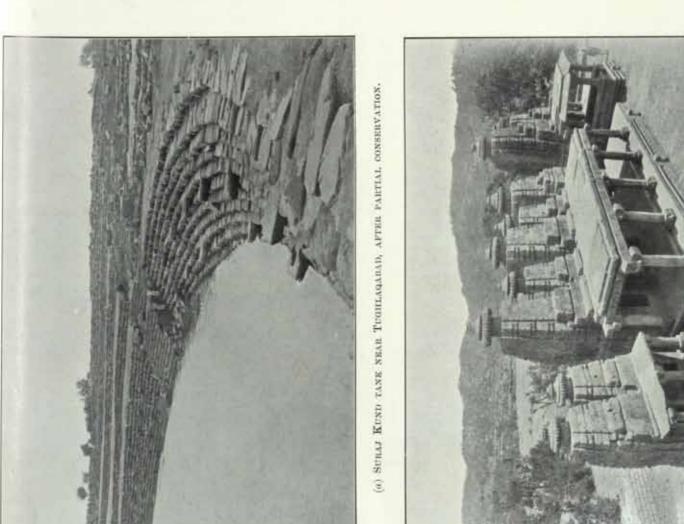
(d) GUIARDEO TEMPLE AT DWARAHAT, APTER BEPAIR.

"The conservation of the Gujardeo temple which had received some attention during the year 1922-23 has now been brought to a finish (Plate IV, d). In the cella, the floor has been repayed with stone slabs and the walls supporting the inner lintel rebuilt with the old material. The retaining wall of the large plinth on which the temple stands had been partly exposed on all four sides by the removal of the debris which hid it in past years. This work has now been completed and the wall thoroughly repaired to the height of 3'-4" from the original floor level. The staircase on the west side has also been repaired together with its balustrades. The top of the plinth was in a dilapidated condition, and most of the stones have had to be taken up and relaid. The monument now presents as satisfactory an appearance as could be expected in its present impaired condition.

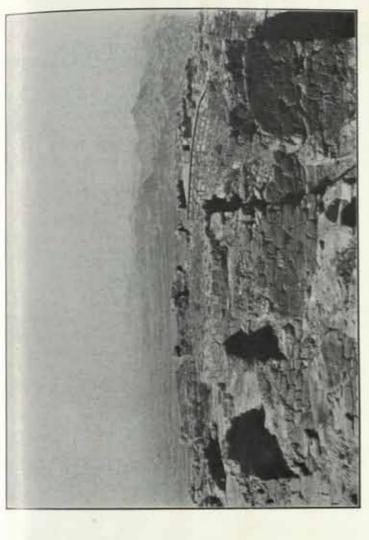
(c) Kachell group at Dwarahat: sheines 1-14, apter conservation.

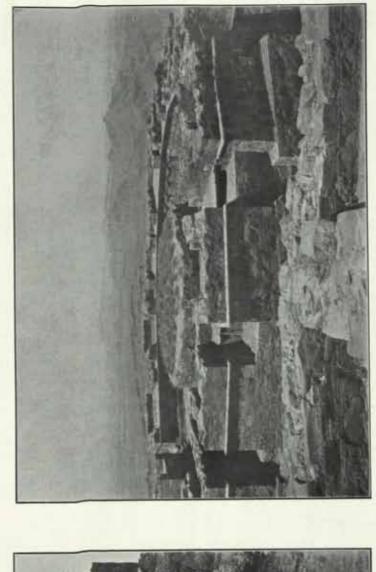
(b) Jamaldarihh: View to north of building No. 7. apthe conservation; prom S.E.

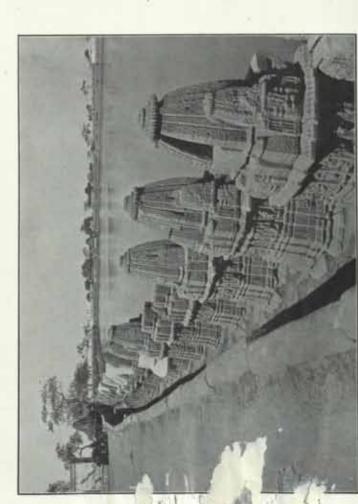
(a) Moti Shahinagh Palace, Ahmadabad District; browing turrets apper removal of modern additions.

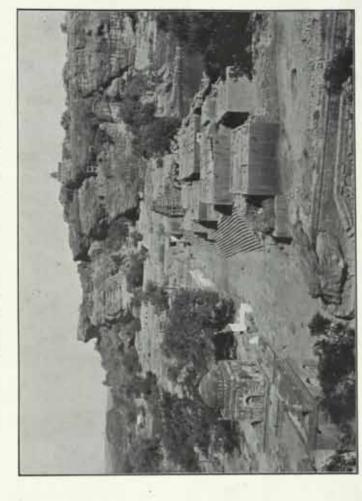
(b) SHAH ALAM BAUZA, AHMADABAD DISTRICT: VIEW SHOWING REPAIRS TO DOMES OF THE MASJID INSIDE THE COMPOUND.

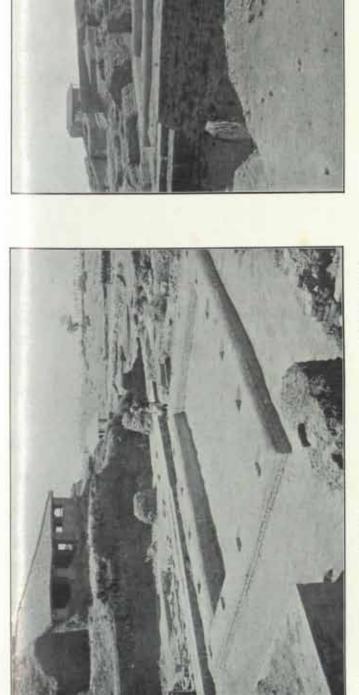
- X.—(a) Nalanda : Monastery No. I-B, after repair of parapet of courtyard, from South-East.
 - (b) Nalanda: Monastery No. I-B during conservation, from South-West.

(a) Nalanda: Monastery No. I.B. apter repair of parapet of courtyard, prom South-East.

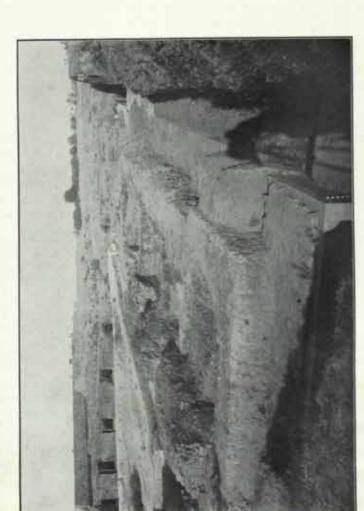
(b) Nalanda: Monastern No. I B. during conservation, from South-West.

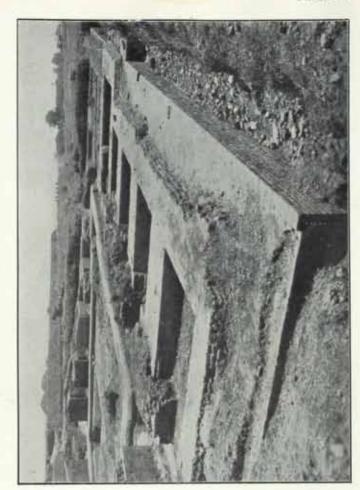
- (c) Nalanda: Monastery No. I-A. South external wall under repair, 1922-23.
 - (d) Nalanda: Monastery No. I-A. South external wall under repair, 1923-24, showing progress of work.

(c) Nalanda: Monastery No. IA, South external wall under hepair, 1922-23.

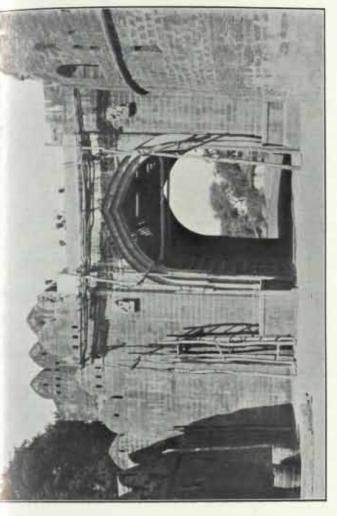
(a) CHANDA FORF: ACHALESHWAR GATEWAY, SHOWING PALLEN FRONT OF THE GATE.

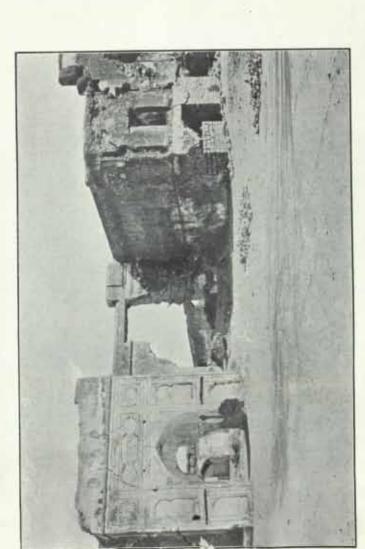
(b) Chanda Fort: Achaleshwar gateway, showing the be-erection of pallen pront in progress.

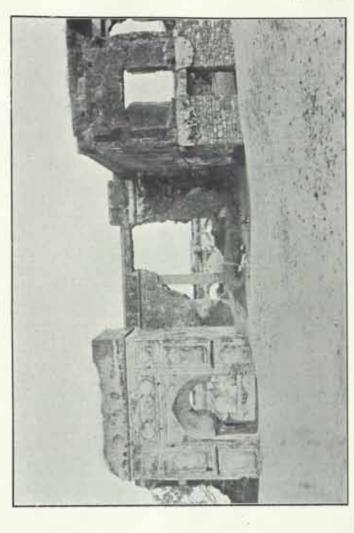
(e) Burhanpur (Nimar); Fort Palace. Entrance gate pront of Dabbar Hall, puming conservation.

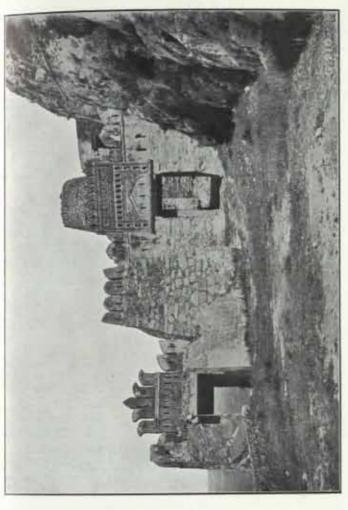
(d) The Raja Mahal, Chandragiel, appen repairs.
